Monitoring Data Record

Project Title: R-2214A COE Action ID: 200330312
 Stream Name: Mud Creek Tributary (Site 3) DWQ Number: 011715
 City, County and other Location Information: Intersection of US 25 and Industrial Park Rd. in Hendersonville, NC
 Date Construction Completed: March 2005 Monitoring Year: (5) of 5
 Ecoregion: _____ 8 digit HUC unit: 06010105
 USGS Quad Name and Coordinates: _____

Mud Creek Tributary

Year 5 Winter – January 2010

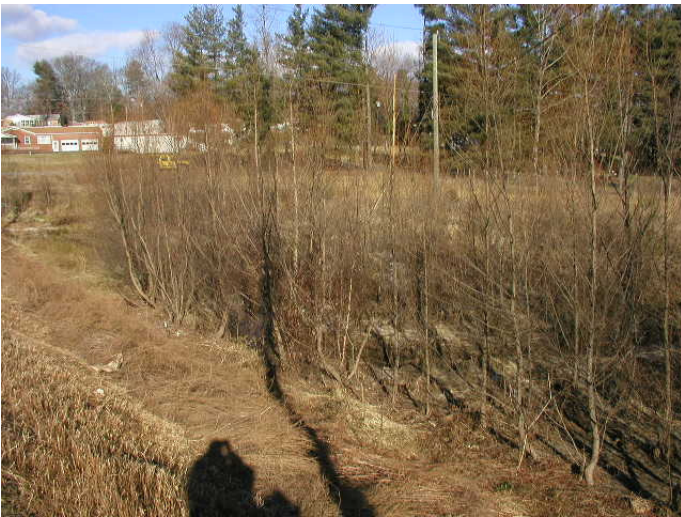
Photo 9 (Overview looking upstream)

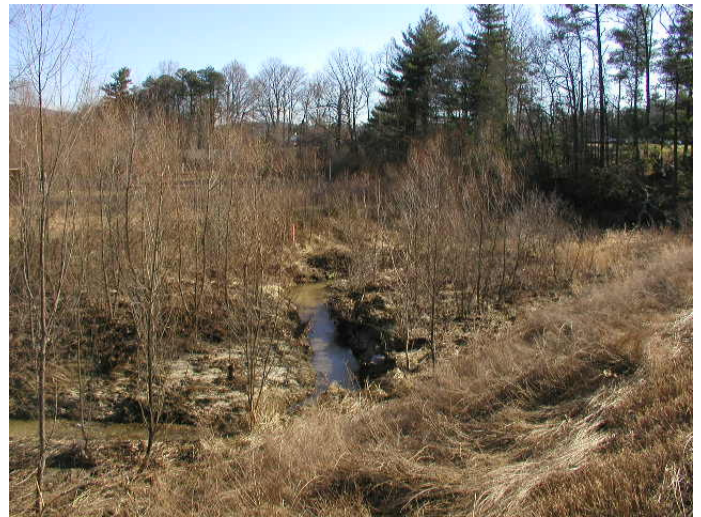
Photo 10 (Overview looking downstream)

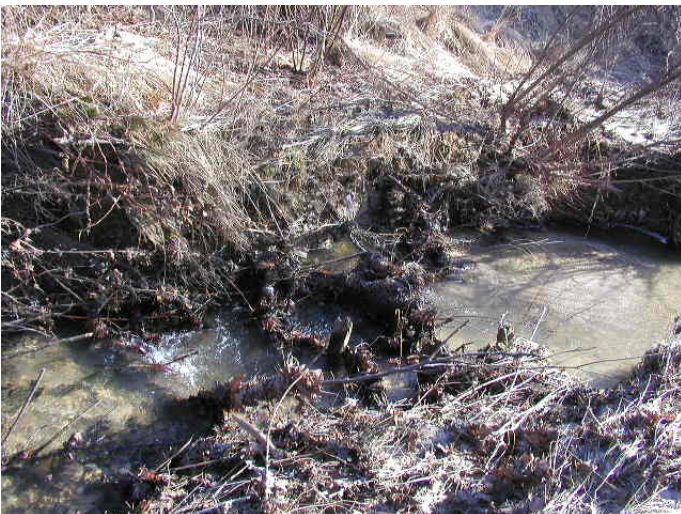
Sta. 184+00
Bank scouring on left bank where beaver dam was removed

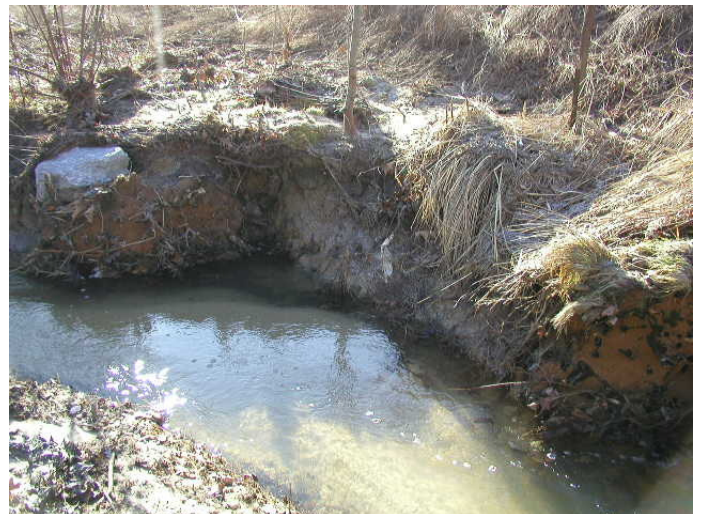
Sta. 184+50
Bank scouring on right bank behind rootwad

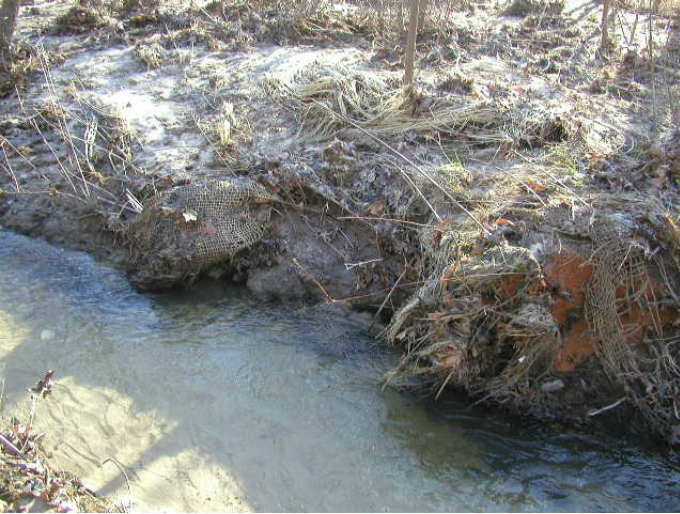
Sta. 185+50

Bank scouring on right bank behind rootwad
